**Site Type:** Large Precious Metals Mining Operation

**Equipment:** Haul Trucks, Underground Trucks, Cranes and Shovels

## Introduction:

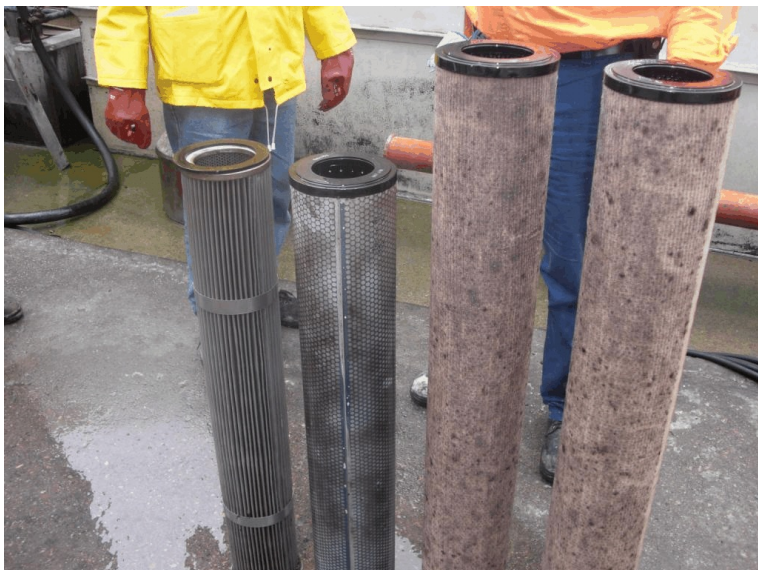
Fuel filters prior to FT-400

The photograph on the left, shows the condition of the primary fuel filter elements prior to treating with biocide FT-400.

The spotting and staining can be clearly seen. Along side the primary filters are the primary screens. These are showing the characteristic black “slimy” deposit associated with “bug” growth.

A site visit confirmed the presence of "bug" growth. At that time the storage tanks were treated with biocide FT-400 to eliminate the existing "bug" problem. Deliveries of fuel to the storage tanks were treated for a short time until the test volume of FT-400 ran out on site.

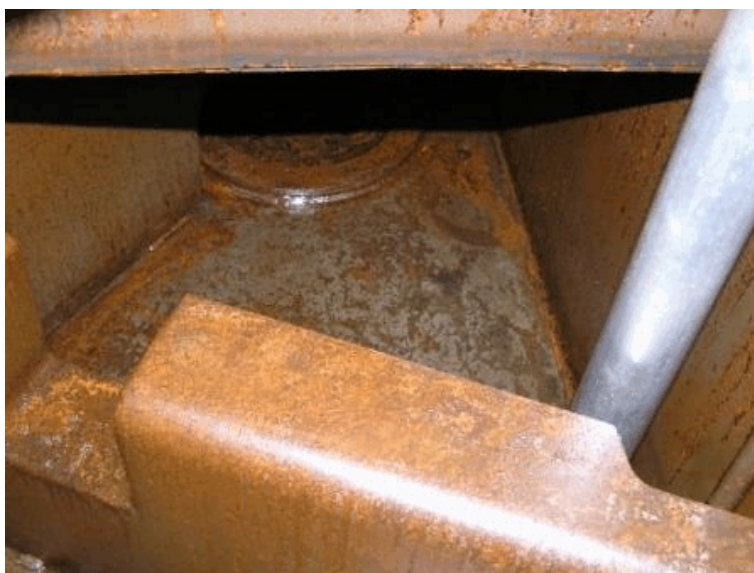
The hidden side of “bug” contamination can be seen in this photograph of heavy corrosion inside a vehicle fuel tank.

Bacterial and fungal growth can generate acidic compounds that accelerate corrosion of steel parts.

Corrosion of fuel injection components is often seen in serious “bug” contaminations.

Corrosion inside vehicle tank

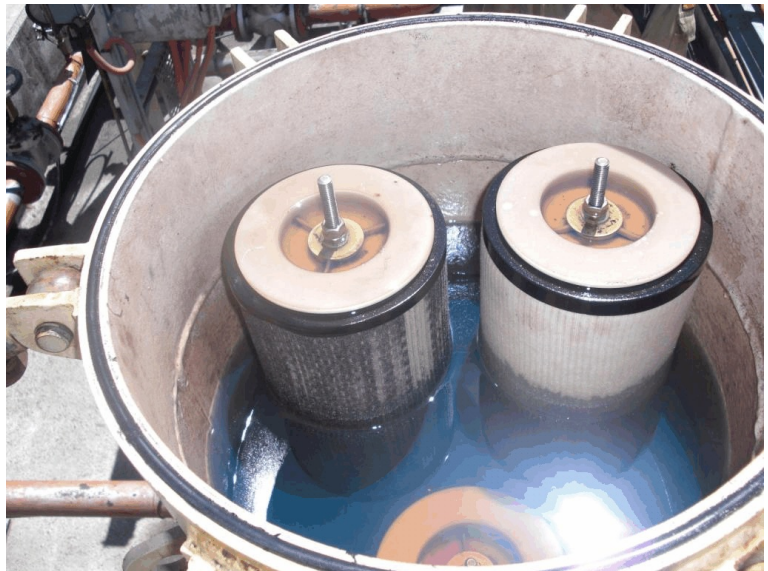
The photograph on the right, shows the condition of the primary filters in fuel that has been treated with FT-400. In both photographs the filters had been in service for the same length of time, (about one month). In the case of the filters on the right, they were left in service.

The filter screens, (not shown), were also clean and free of build up.

After treating with FT-400

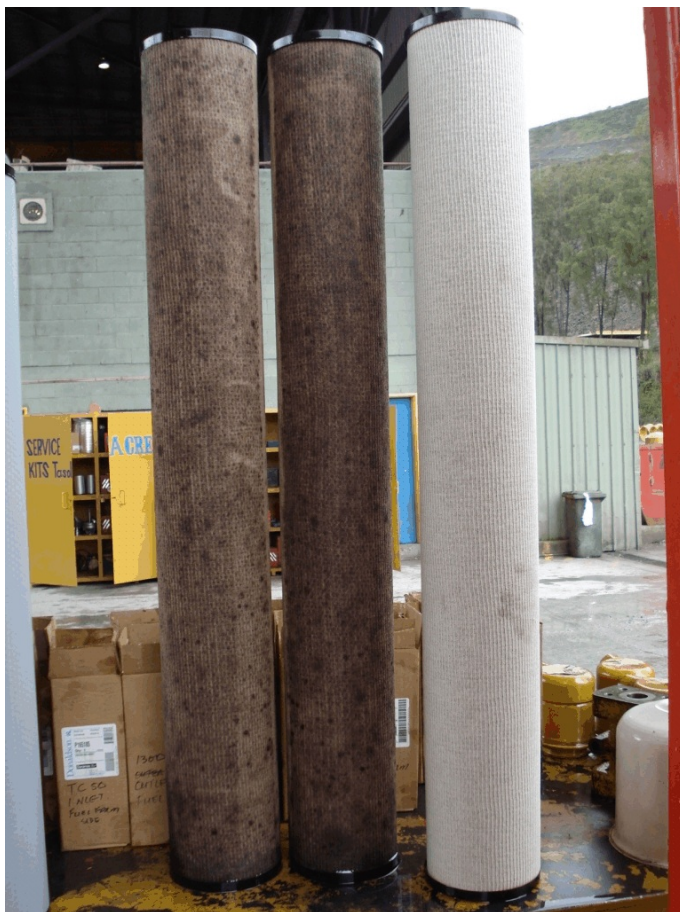
Filters from untreated and treated fuel

This photograph shows filters on the left from untreated diesel fuel, and on the right from fuel treated with FT-400.

The filters on the left show the effect of one month in diesel contaminated with “bug” growth.

The white filter on the right shows the filter appearance after one month in diesel fuel treated with FT-400.

The filter on the right is still fully serviceable.

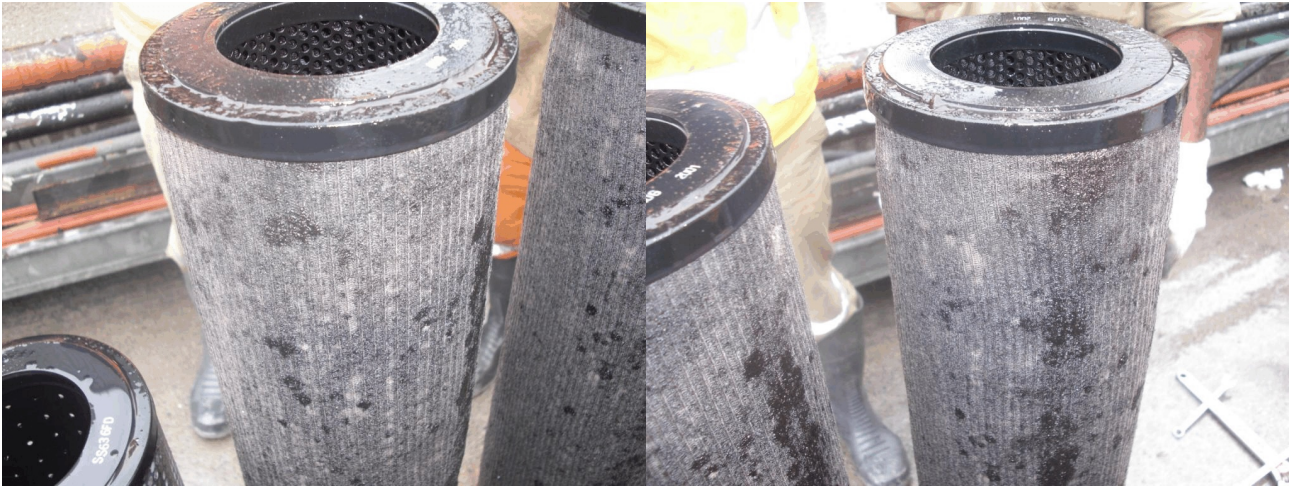
Filter 1 without FT-400 treatment

Filter 2 without FT-400 treatment

These photographs of the primary filters from units 1 and 2 clearly show the spotting and staining of “bug” growth. This has taken about one month to develop, and is consistent with past experience with untreated fuel.

A black sticky deposit present in the primary screens, was also present on the individual vehicle filters

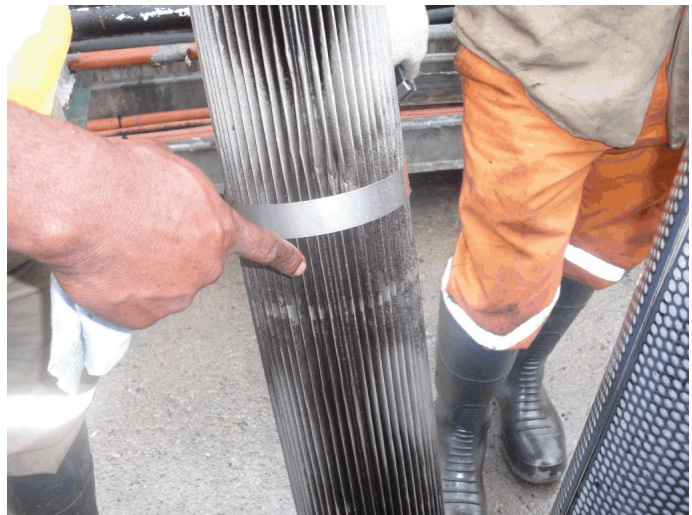
The filter screen in this photograph clearly shows the black sticky deposit.

Filter screen 1 without FT-400 treatment
